Roadway Condition Report *Route 17 In Sullivan County*

MEMORANDUM
DEPARTMENT OF TRANSPORTATION

SUBJECT ROADWAY CONDITION REPORT
ROUTE 17 IN ~~SULLIVAN~~ COUNTY
BROOME

TABLE OF CONTENTS

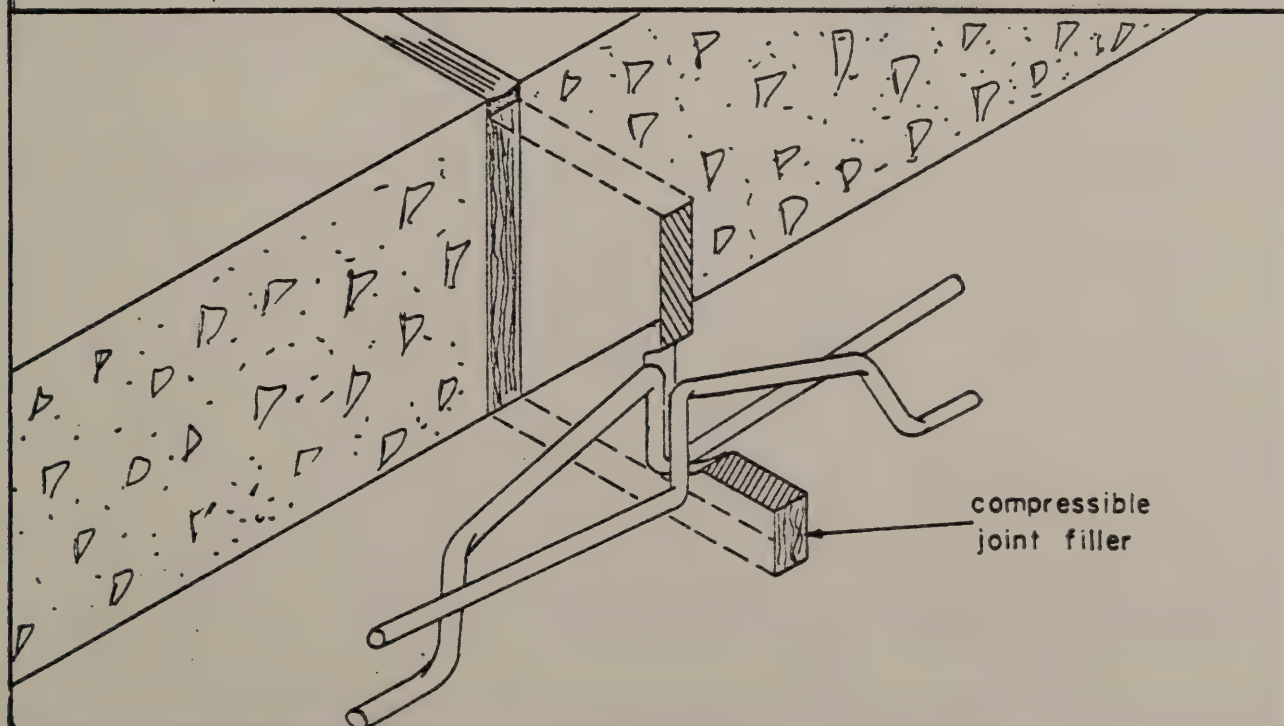
Figure No.7
HAIRPIN DOWELS

A core in one of the transverse joints shows that it is a formed expansion joint. It has approximately 1/4 inch of an asphalt material for its full depth to provide a sealer and allow for expansion. The transverse joint load transfer device is an unknown type, but resembles the hairpin dowels in Figure 7 in Physical Research Report RR-66-2. See Page 25. The presence of joint faulting could not be determined from this core. However, the use of this joint type was discontinued due to severe faulting problems.

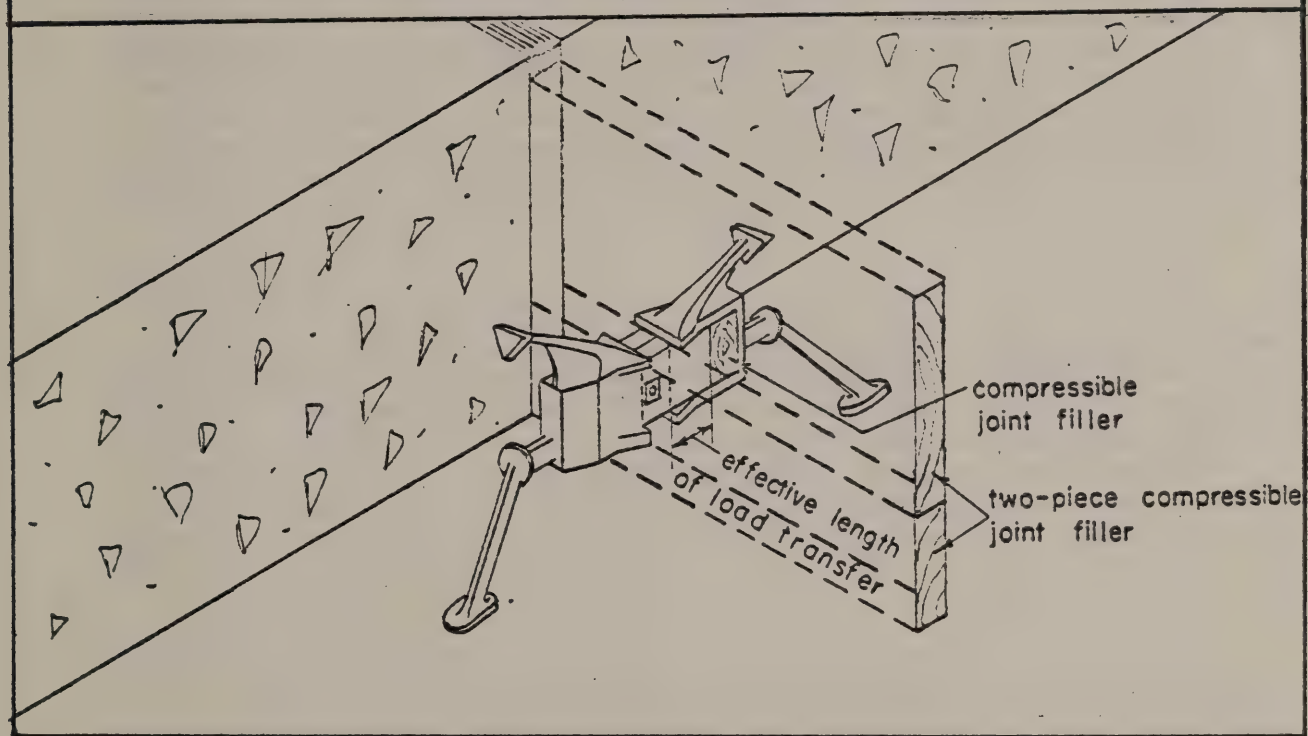
Figure No. 8
TWO-PIECE MALLEABLE IRON SLEEVE

"Acme" Type Load Transfer Device
(also used in contraction joints)
